## Space Environmental Effects on Silvered Teflon Thermal Control Surfaces

C. S. HEMMINGER, W. K. STUCKEY, and J. C. UHT  
Mechanics and Materials Technology Center  
Technology Operations

15 September 1991

THE AEROSPACE CORPORATION  
El Segundo, California

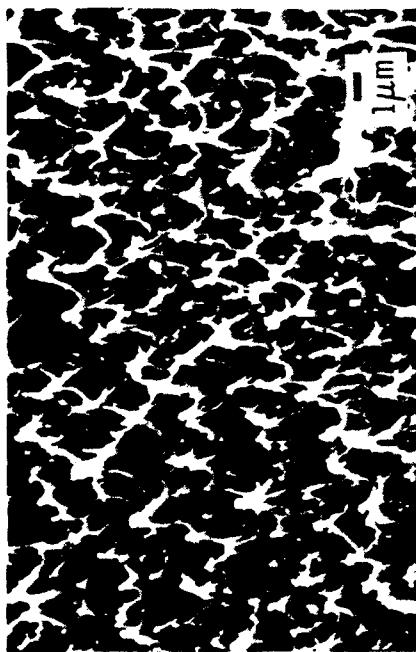
The leading edge samples were uniform in appearance from rows 7 through 11. Typical results of analyses with SEM and XPS are shown in Figure 3. The control surface, which is a non-flight FEP surface, is featureless in the SEM while the flight sample shows a typical erosion pattern in FEP for high velocity atomic oxygen erosion. The XPS data for the control surface shows carbon and fluorine only. The XPS analysis of the exposed surface shows that the surface composition of the FEP remaining after the erosion is indistinguishable in carbon and fluorine composition from the control, with trace amounts of some contaminants (Si, N, S, and Cl) and measurable oxygen present. This oxygen could be from the atomic oxygen interaction or from water adsorption from the atmosphere after retrieval. Water adsorption could be enhanced on the erosion-roughened surfaces, which have much higher surface area than the control surfaces. Some variations in the erosion pattern on leading edges were observed as shown in Figure 4.

MOLE %			
C	F	O	OTHER
27	72	0.4	TRACE Si, N, S, Cl
27	73	TRACE	NONE DETECTED

Figure 3. Leading edge sample of Ag/FEPM compared to control sample. Typical results of analyses with SEM and XPS.
